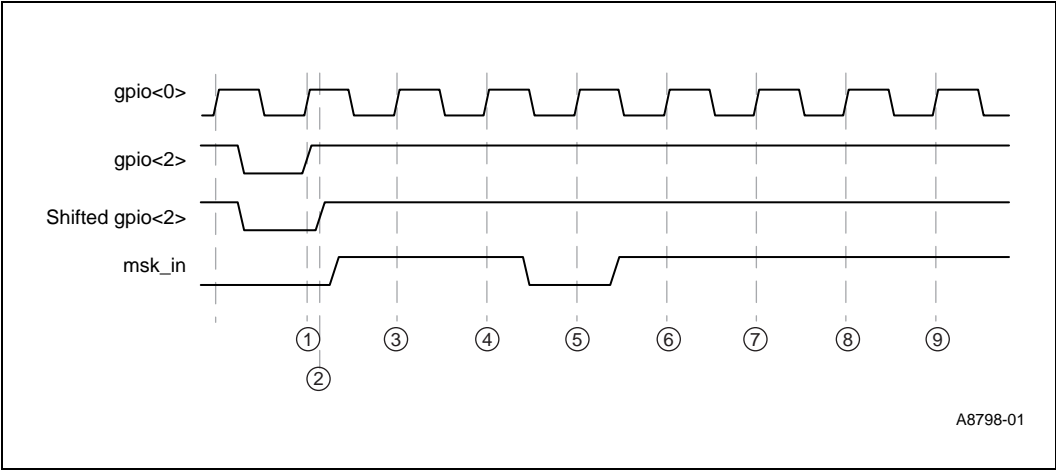
Figure 21. Clock Mask and Load Shift Timing

1. The **gpio<2>** original coming from the 21154 does not provide 3ns setup time needed to provide the parallel load enable **PE#** of the 74F166.
2. The shifted **gpio<2>** is delayed by ~9ns to provide ample setup time to enable the parallel of the shift register connected to pin 15 of the 74F166.
3. Bit 15 input **D6** of the shift register is pulled high, to Vcc.
4. Bit 14 input **D7** is pulled high, to Vcc. These signals are not used internally in the 21154.
5. Bit 13 **s_clk_o<9>** is a feedback to the 21154 **s_clk_o** input. To enable **s_clk_o<9>** in all cases the **D5** input of the shift register is grounded, to Vss.
6. Bit 12 **s_clk_o<8>** is disabled.
7. Bit 11 **s_clk_o<7>** is disabled.
8. Bit 10 **s_clk_o<6>** is disabled.
9. Bit 9 **s_clk_o<5>** is disabled.

Workaround: In order to provide an appropriate setup time, a buffer must be added to delay **gpio<2>** with respect to **gpio<0>**. This buffer (or buffers) provides the delay for **gpio<2>** to correctly load the parallel data inputs of 74F166 registers. A setup time of at least 3ns is required at the shift register for **PE#** to load.
