TABLE 2: SILICON ISSUE SUMMARY

Silicon Errata Issues

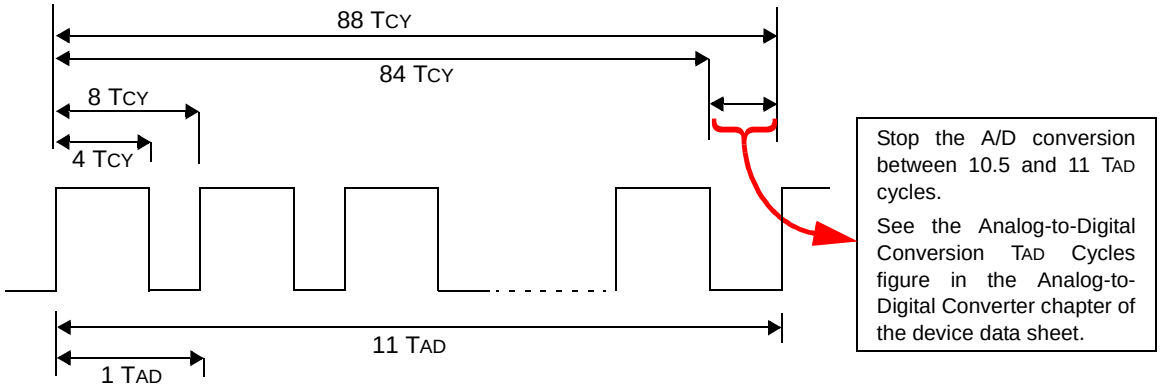
FIGURE 1: INSTRUCTION CYCLE DELAY CALCULATION EXAMPLE

An ADC conversion may not complete under these conditions:

1. When FOSC is greater than 8 MHz and it is the clock source used for the ADC converter.
2. The ADC is operating from its dedicated internal FRC oscillator and the device is not in Sleep mode (any FOSC frequency).

When this occurs, the ADC Interrupt Flag (ADIF) does not get set, the GO/DONE bit does not get cleared, and the conversion result does not get loaded into the ADRESH and ADRESL result registers.

In Figure 1, 88 instruction cycles (TCY) will be required to complete the full conversion. Each TAD cycle consists of 8 TCY periods. A fixed delay is provided to stop the A/D conversion after 86 instruction cycles and terminate the conversion at the correct time as shown in the figure above.

Method 3: This method is provided if the application cannot use Sleep mode and requires continuous operation at frequencies above 8 MHz. This method requires early termination of an ADC conversion. Provide a fixed time delay in software to stop the A-to-D conversion manually, after all 10 bits are converted, but before the conversion would complete automatically. The conversion is stopped by clearing the GO/DONE bit in software. The GO/DONE bit must be cleared during the last ½ TAD cycle, before the conversion would have completed automatically. Refer to Figure 1 for details.

Note: The exact delay time will depend on the TAD divisor (ADCS) selection. The TCY counts shown in the timing diagram above apply to this example only. Refer to Table 3 for the required delay counts for other configurations.

```
BSF    ADCON0, ADGO   ; Start ADC conversion
                      ; Provide 86
                        instruction cycle
                        delay here
BCF    ADCON0, ADGO   ; Terminate the
                        conversion manually
MOVF   ADRESH, W      ; Read conversion
                        result
```
