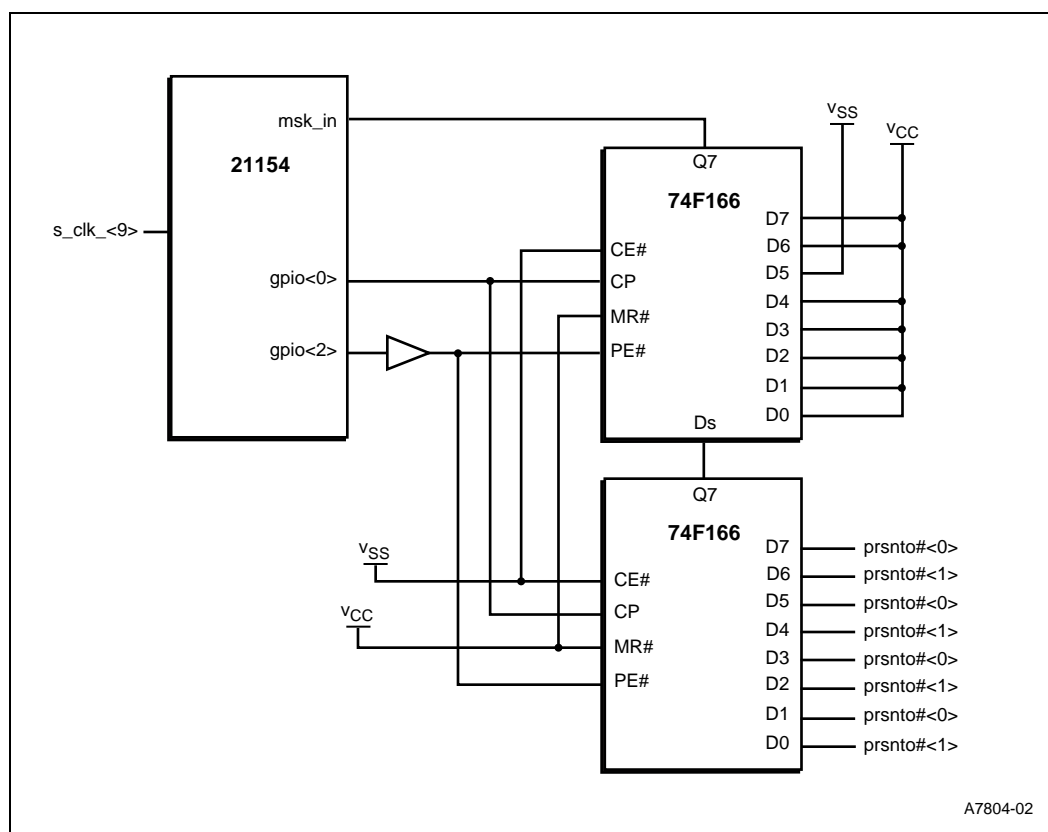
12. Section 10.2, Secondary Clock Control, Figure 19

Figure 19 Example of GPIO Clock Mask Implementation on the System Board

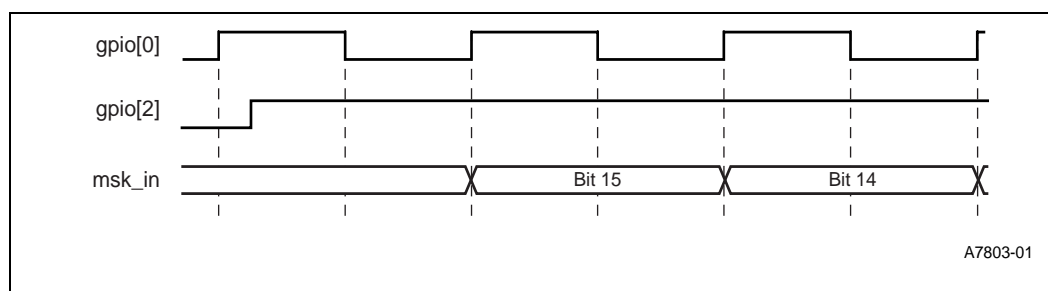
13. Section 10.2, Secondary Clock Control, Figure 20

Figure 20. Clock Mask and Load Shift Timing

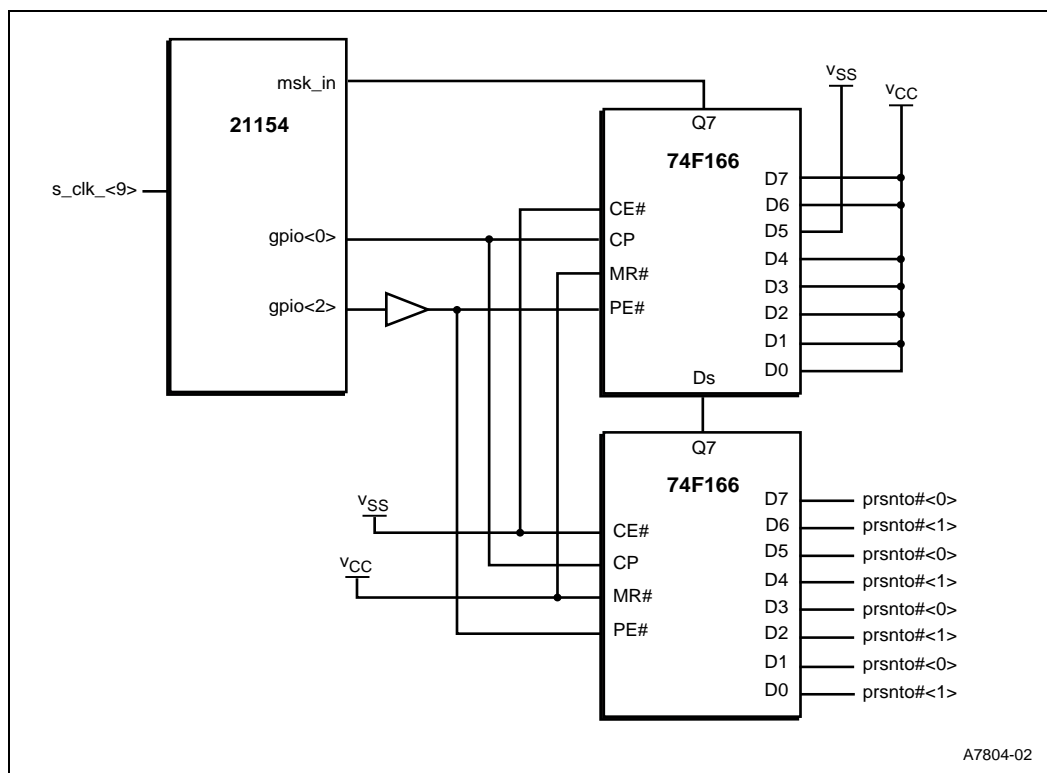
18. Section 4.4.1, Serial Clock Mask Shift, Figure 3

Figure 3 Example of GPIO Clock Mask Implementation on the System Board

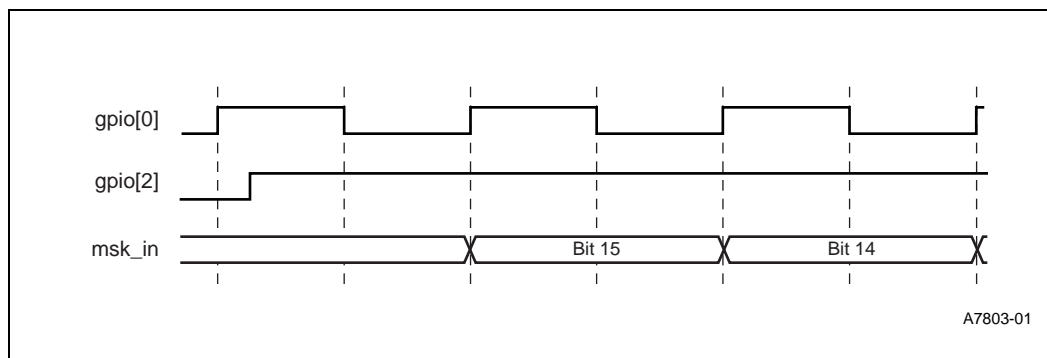
19. Section 4.4.1, Serial Clock Mask Shift, Figure 4

Figure 4. Clock Mask Load and Shift Timing
